Executive Summary:

Site/Project Location: Epping terminal/Epping ND

Date of Inspection: 1 November 2016

235 PU-14-842 Filed: 11/9/2016 Pages: 6
Construction Inspection Report - 1 November 2016

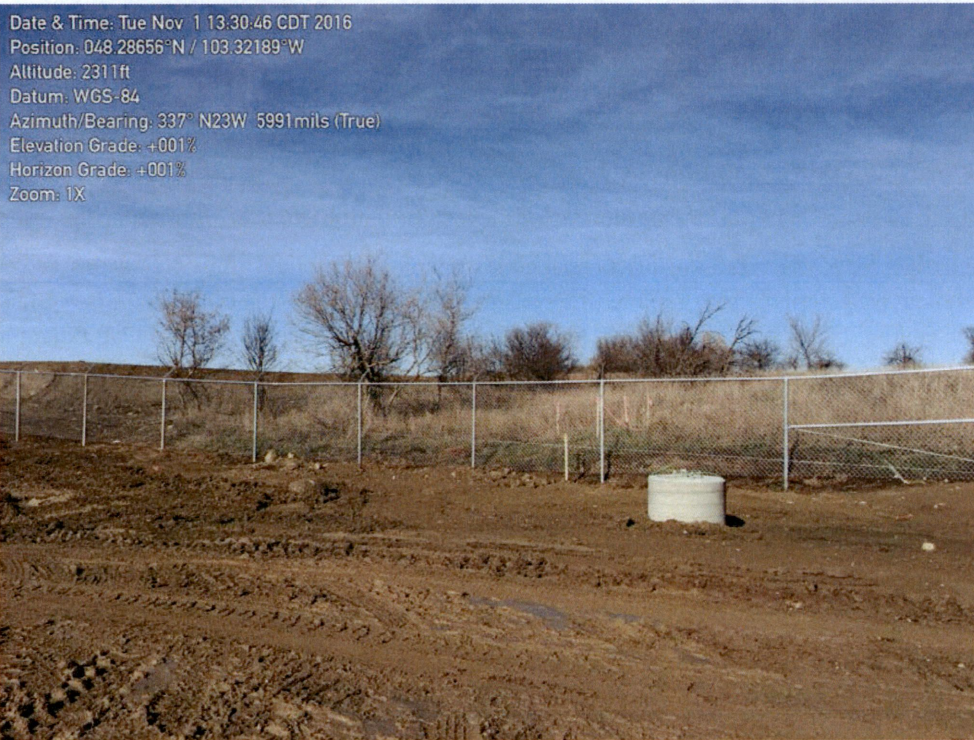
Grade work complete including north site boundary up to and through existing tree line. Per info from prior January 2016 inspection, no trees were scheduled for removal. Site rep repeated claim no trees were impacted at this site. Bare ground throughout except scoria beneath pipe alleys.

Report Photo #1 "Trees along North Property Line"

During "As Built" inspection, focus on sediment/BMP to roadside ditches; report borrow area and wetland disturbance to PSC. Verify special SW event inspection within 48 hours of 10/31/16. Verify tree mitigation.

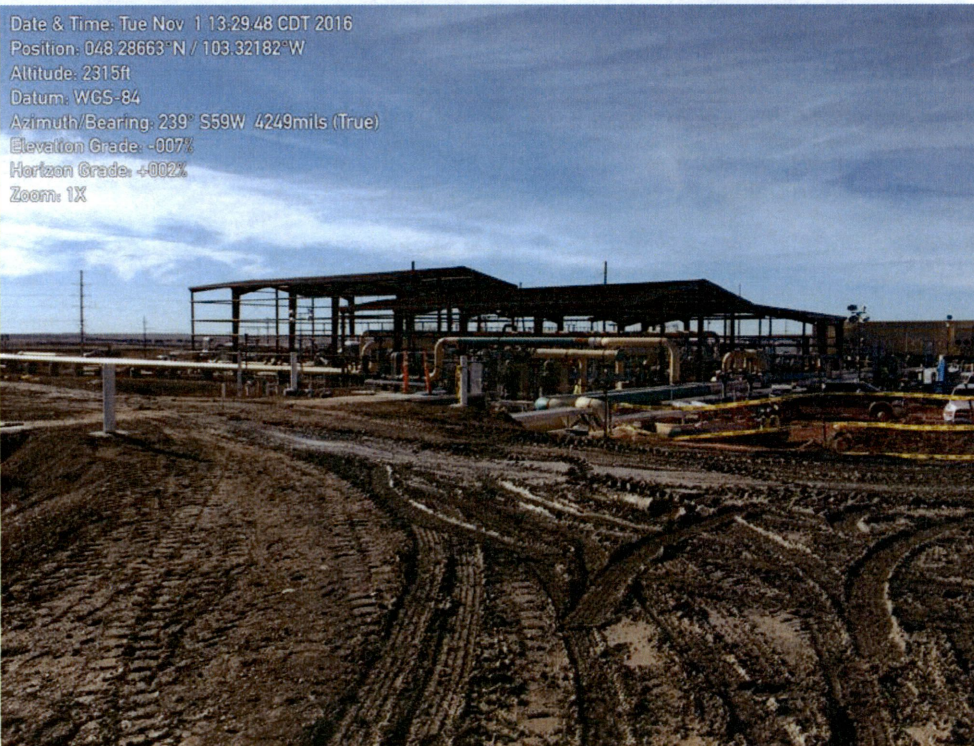
Report Photo #2 "Process Area"

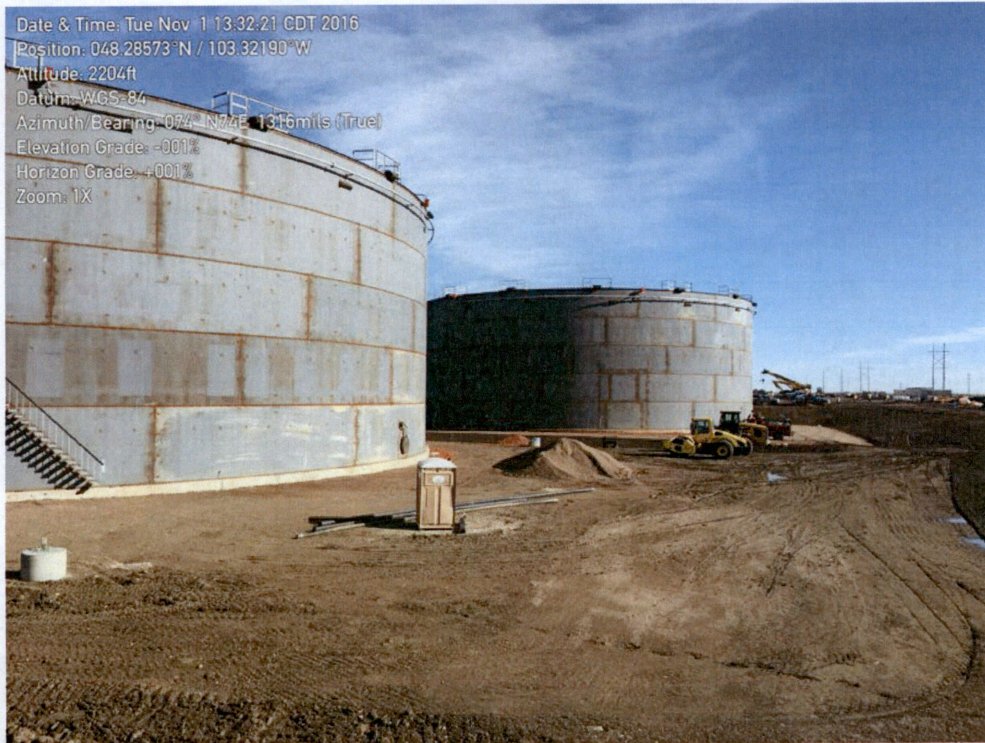
Robert Welch escorted Keitu's staff during the inspection and answered questions. He outlined current status of construction as well as plans to complete project. Matrix hydro tested the tanks in early September. Both are internally coated and are considered complete. Electrical subcontractors are at the site installing power and instrumentation connections. Site layout i.e. tank locations different than submitted in application but within approved boundaries. Perimeter chain link security fence largely installed. Waiting on their clients to install connecting pipelines to the site.

Report Photo #3 "Tanks"

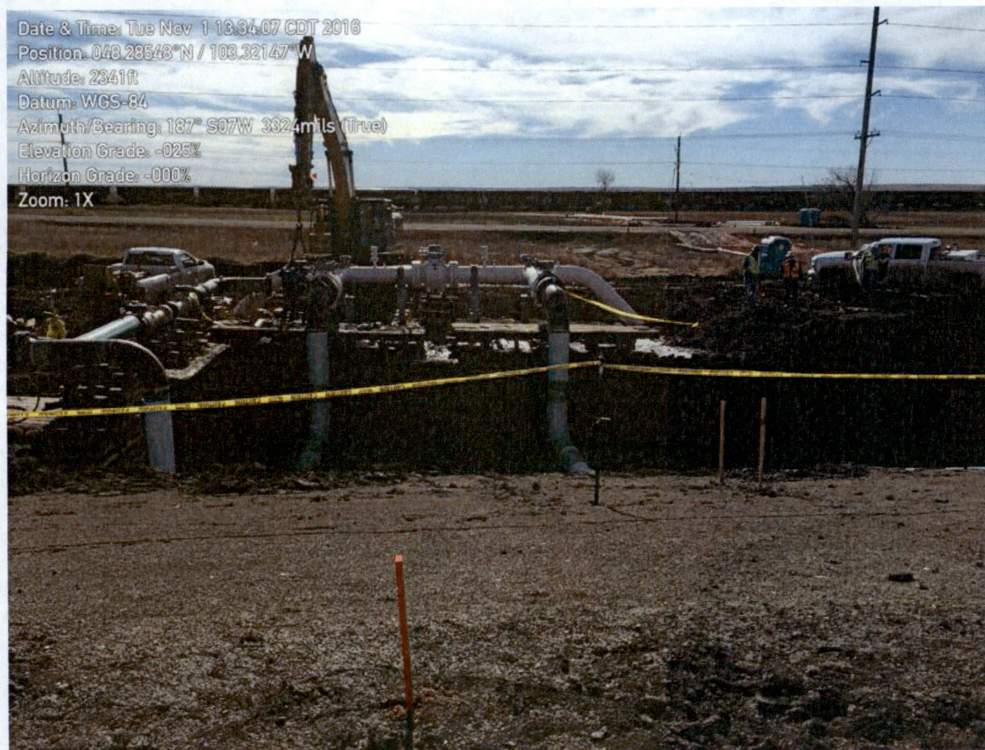
Report Photo #4 "Pipeline Tie-In"

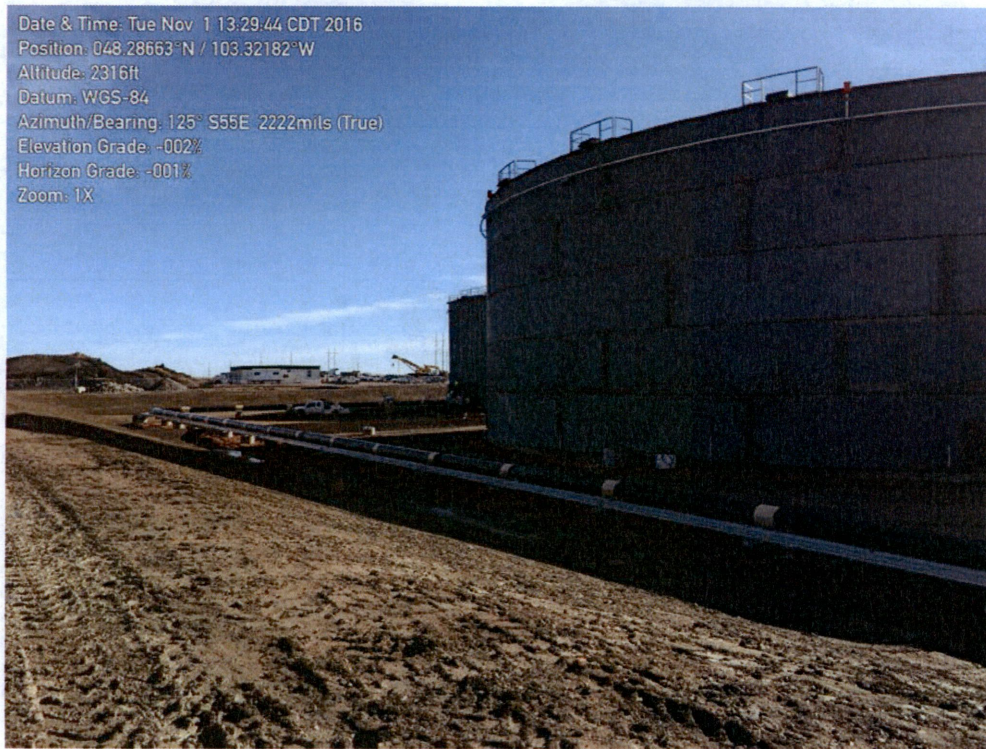
Based on desktop study of historical aerial photos, prior drainage to site was largely to the northeast, prior to construction. Site work appears to have altered flow toward west and south along County Road 8 / 60th St NW including permanently partially filling a prior existing wetland area, 23,800 sq ft estimated impact.

Soil borrow area outside of approved area as well as soil backfill to wetland and work zone on east side of site. Trees have also been removed despite reports to contrary. See 2016 aerial photo. If the northeast wetland is US ACE jurisdictional, a permit is required and currently not on file. Threat of sediment discharge to roadside ditches remain but "hard freeze" conditions likely in near future.

Report Photo #5 "Possible Wetland Infill" (Area Along Left Photo Border)

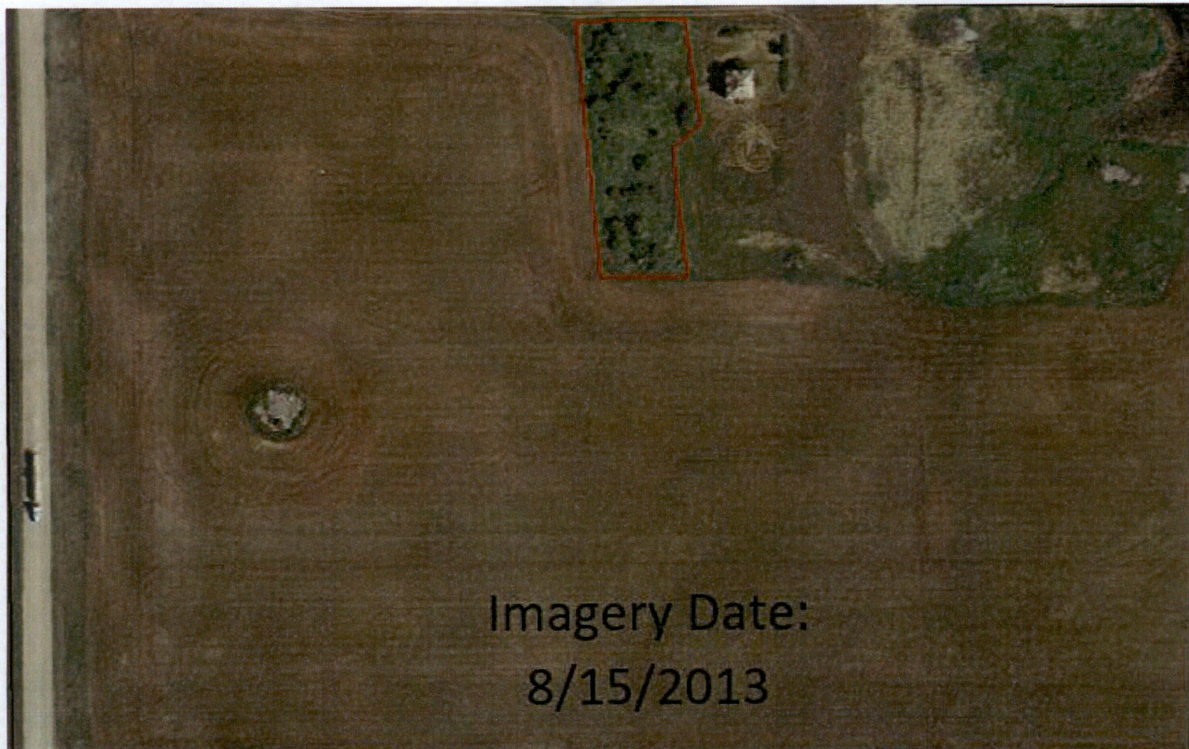
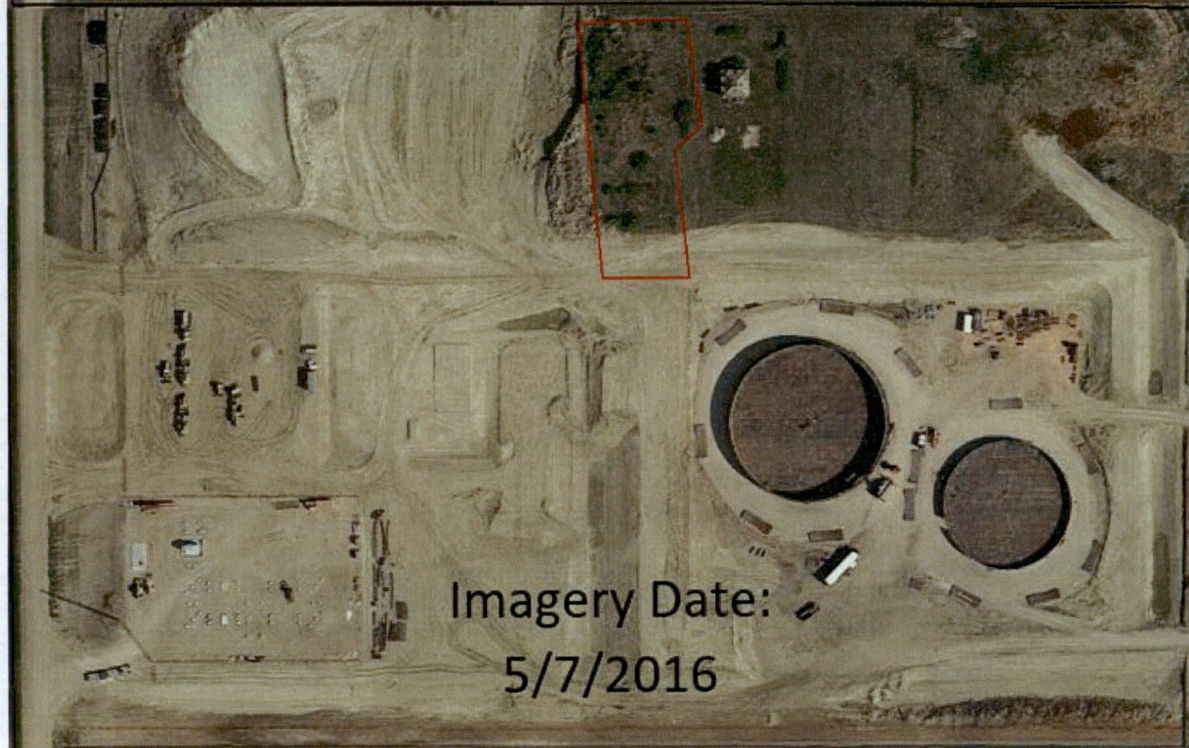
Aerial Photos of Terminal Site (Note Before and After Treed Area Shown in Red):

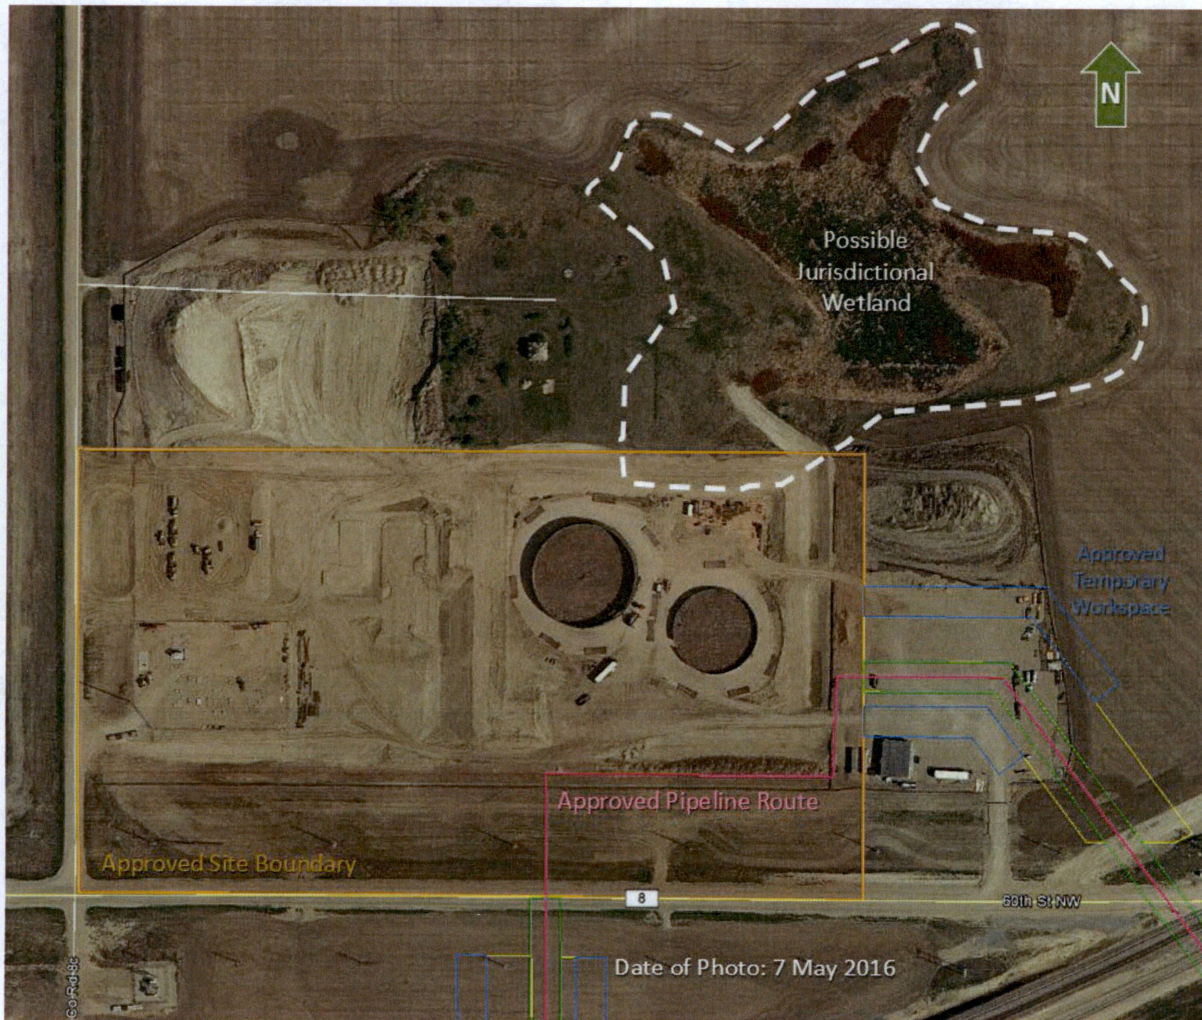
A 3+ acre disturbance immediately north of site beyond approved PSC facility boundaries noted. Site civil work contractor JMAC leased land from owner to create borrow pit to supply suitable soil for construction due to poor quality soils/failed compaction tests during project construction. All grade work was reported complete.

Aerial Photos of Terminal Site Depicting Work Areas & Disturbances Outside of Approved Area
